NFCC REVIEW

Cathedral Yard Fire, Exeter
28th October 2016

Review Completion Date: 25th July 2019

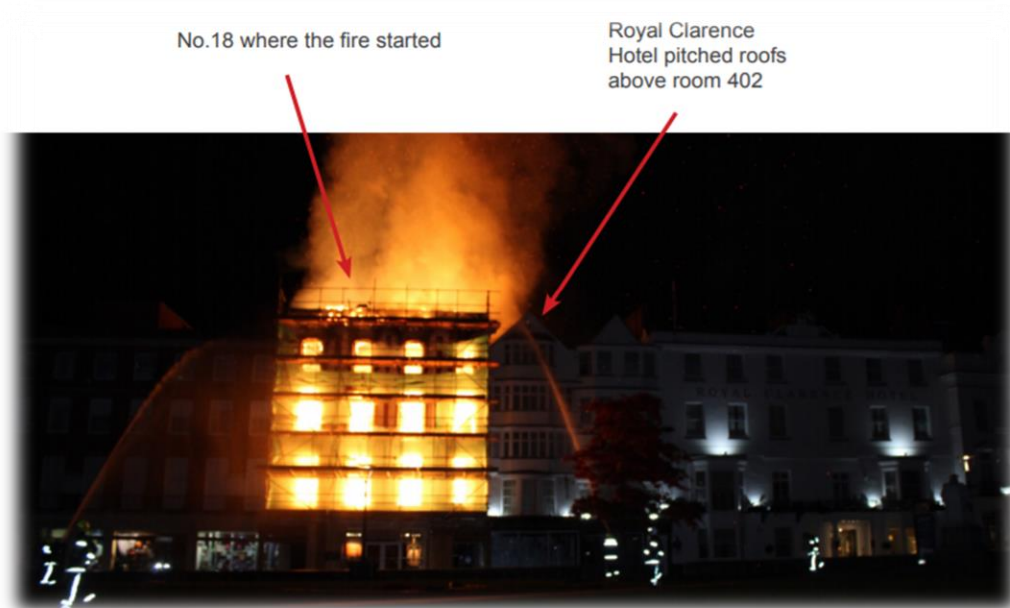
Figure 5 - Fire at No.18

that the fire was being brought under control in No.18.⁶⁰ An ALP operator also stated during Phase II that once he had started to put water on the fire in No.18, it quickly began to have an effect in reducing its size.⁶¹ Photographic evidence from the incident⁶² supports the view that post 0650hrs, there was little fire and less smoke rising from No.18 when compared to 0518hrs when crews first arrived (Figure 5).

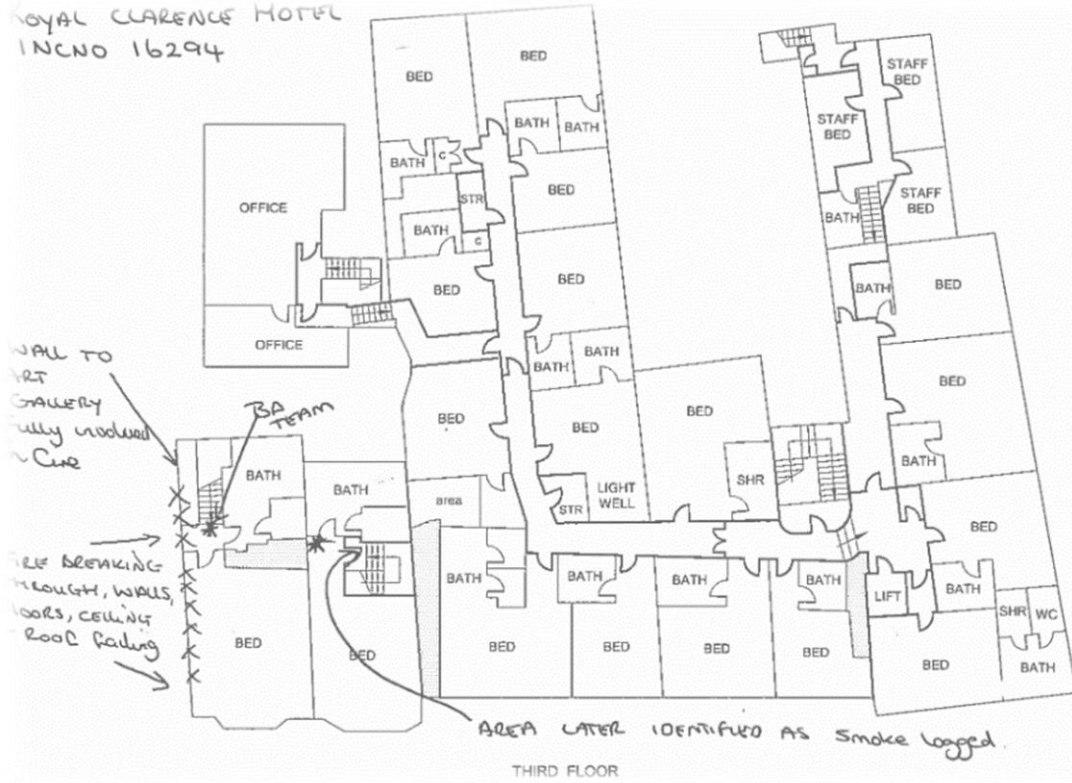
Figure 6 - Annotated third floor plan (taken from Sector 4 commanders written statement)

When reviewing the floor plans in Figures 6 and 7, an observation made by the review team is the absence of detail around what firefighting actions, or searches, took place elsewhere on the first, second or third floor in the RCH up to 1018hrs. In all the interviews conducted with BA wearers during Phase II, nobody stated that they had accessed the entire third floor, or any other parts to the rear of the hotel. This was because the focus of firefighting actions was on the pitched roof apex of the RCH to the front left of the hotel and internally within rooms 401 and 402. The complex layout of the RCH was highlighted to the review team when assessing the floor plans for the hotel and speaking to individuals during Phase II, where it would appear that the only access to rooms 401 and 402 on the third floor would have been from a separate staircase from the second floor (Figure 8).⁵³ As a result, and with no access to the rest of the third floor in the RCH from rooms 401 and 402, BA crews would have needed to have been specifically briefed to go to other parts of the third floor via a different route in order to carry out tasks in those areas. The external layout of the buildings occupying Cathedral Yard around No.18 was also highlighted as complex by an ALP operator, who stated during Phase II that the complex layout of buildings, or '*Labyrinth*' as he described, made it difficult to see what was happening further back on the roof of the RCH and surrounding buildings (Especially at the height of the fire in No.18).⁵⁴

Based on the annotated plan submitted with the initial sector 4 commanders written statement during the D&SFERS review (Figure 6 and 7), the conditions he highlighted on this floor plan were focused to the front left section of the hotel and not anywhere else. The front left section of the RCHs roof apex was being well monitored externally to that point, with an ALP positioned above it stripping away tiles on the roof and exposing what was beneath (Figure 10). Interviews with the ALP operators, together with drone footage from above the RCH, shows that where ALP crews were working there did not appear to be any signs of fire spread into the roof.⁹⁷ Internally there were also a number of entries made into specific areas of the RCH prior to 1018hrs, which are detailed in post Internal collapse section of this report (Section 2.3.4).

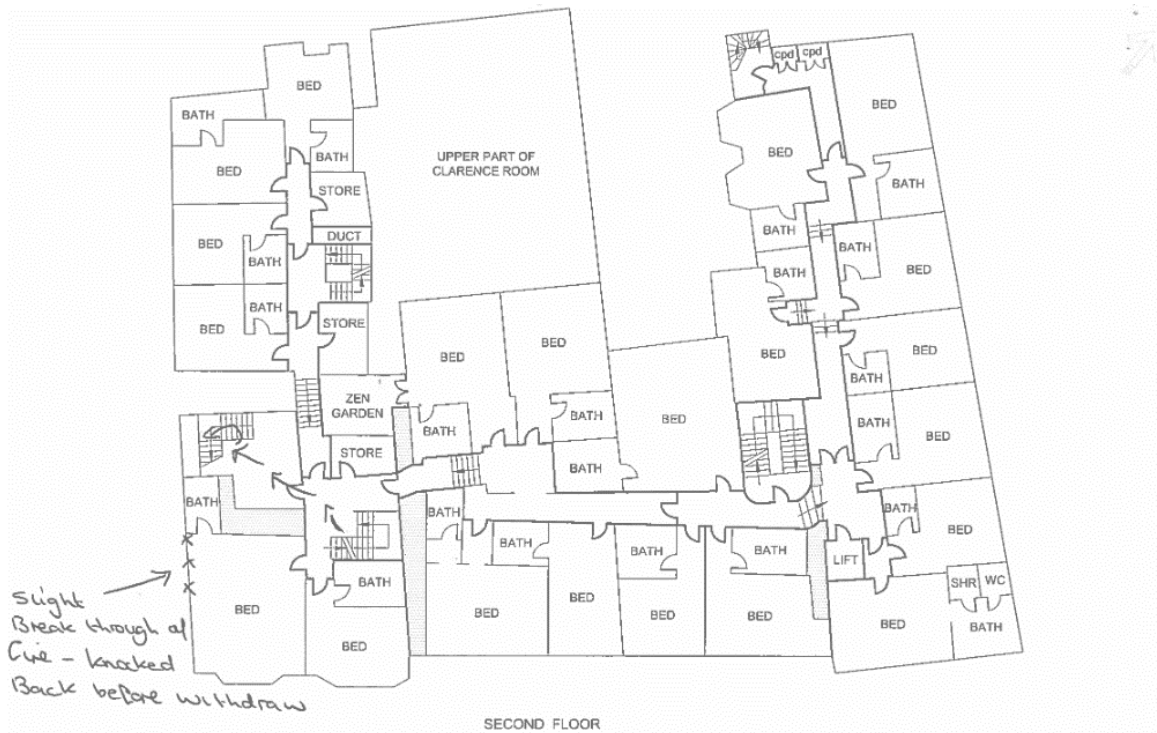
Figure 7 - Annotated second floor plan (taken from Sector 4 commander written statement)

Supporting a notion that conditions inside the RCH posed a risk to firefighters was an early change in the control measures implemented by the initial sector 4 commander in charge of personnel operating in the hotel.³⁷ While initially crews entering into the RCH did so without Breathing Apparatus (BA), when they had to withdraw due to the conditions inside the hotel they were then re-committed by the sector 4 commander with BA.³⁸ The evidence provided by BA wearers³⁹ has confirmed that the fire had spread internally into the RCH within an hour of the first crews arriving at this incident, although a message sent at 0532hrs does refer to the spread of fire to the hotels pitched apex roofs.⁴⁰ With regards to the activity undertaken inside the RCH in these early stages of the incident, firefighting actions predominantly took place at the front left section of the RCH, in rooms 401 and 402 on the third floor above the Well House Tavern where images show the fire to have spread (Figure 5).⁴¹ Figure 6 is a third floor plan of the RCH which was annotated and included in the written statement provided by the initial sector 4 commander during the D&SFERS review. The annotation visualises what was happening within the RCH and provides the location of where crews were working, which was verified by a number of BA wearers interviewed during Phase II.⁴² In addition to this the sector 4 commanders written statement to the D&SFERS review also refers to the fire breaking through into the RCH on the second floor below room 402, which was subsequently knocked back by a BA team prior to them being withdrawn from the hotel (Figure 7).⁴³

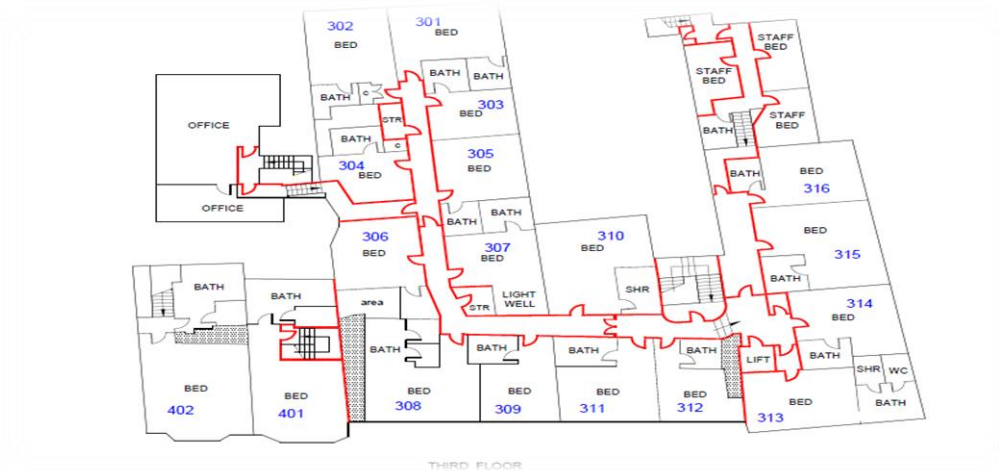
Figure 8 - Royal Clarence Hotel floor plan (Third floor)

As a result, there was no evidence to indicate that the rear of the RCH, especially on the third floor, was ever searched by the BA crews in the initial stages of this incident. The initial focus of resources, where the fire could be seen externally impinging the RCH pitched roofs, is significant. With no evidence that the rooms marked 'Office' on the plan, or indeed other parts of the hotel were being monitored on an ongoing basis, it remains unknown as to whether there was any internal fire spread into these areas from No.18 prior to the escalation at 1018hrs.⁵⁵ Where this is relevant to the review is that it was an area further back into the RCH that the true extent of fire spread into the hotel was first observed by an ALP operator working by the apex roof above room 402, prior to the escalation.⁵⁶

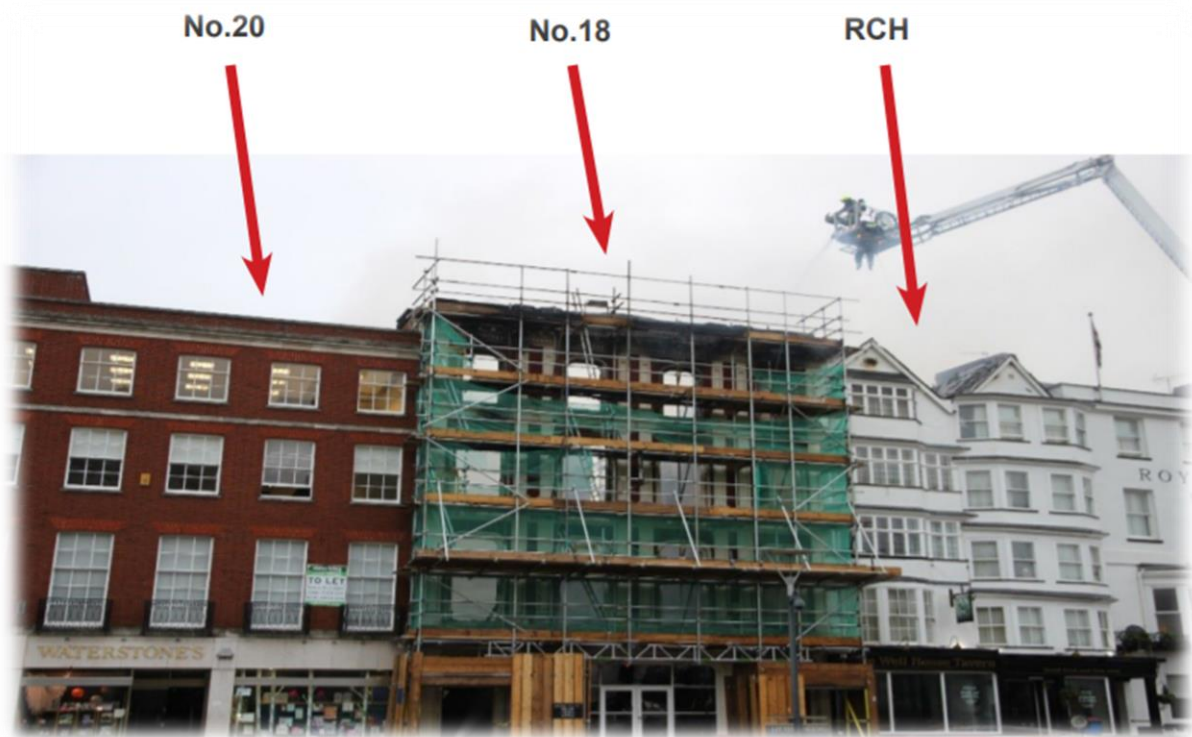
Figure 9 - View from Cathedral Green (Post internal collapse of No.18)

Whilst firefighting actions took place after the internal collapse, they were largely external in sectors 1, 2 and 3 prior to the relocation of an ALP to the front of the RCH (Sector 4).⁶³ However, due to the conditions inside the RCH, firefighters wearing BA had been withdrawn resulting in no firefighting taking place within the hotel and more defensive tactics being deployed. While a number of entries were reportedly made into the RCH, these were for specific purposes only and did not form part of a formal watching brief.

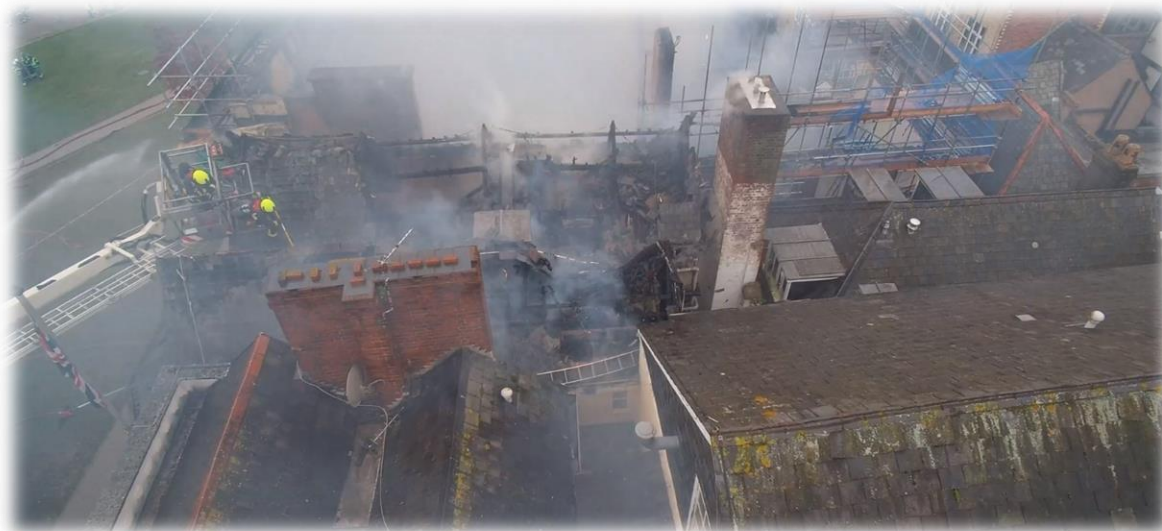
Figure 10 - Drone screenshot, pre escalation of fire into RCH

sector 4 commanders written statement to the D&SFRRS review that he checked the second floor and found no smoke or any *'smoke in the areas of the third floor the other side of the chimney breast'*.⁶⁵ This would have been an important area of discussion with the sector 4 commander if the review team were given the opportunity to speak to him, as there are a number of chimney stacks visible in Figure 10.
