NFCC REVIEW

Cathedral Yard Fire, Exeter
28th October 2016

Review Completion Date: 25th July 2019

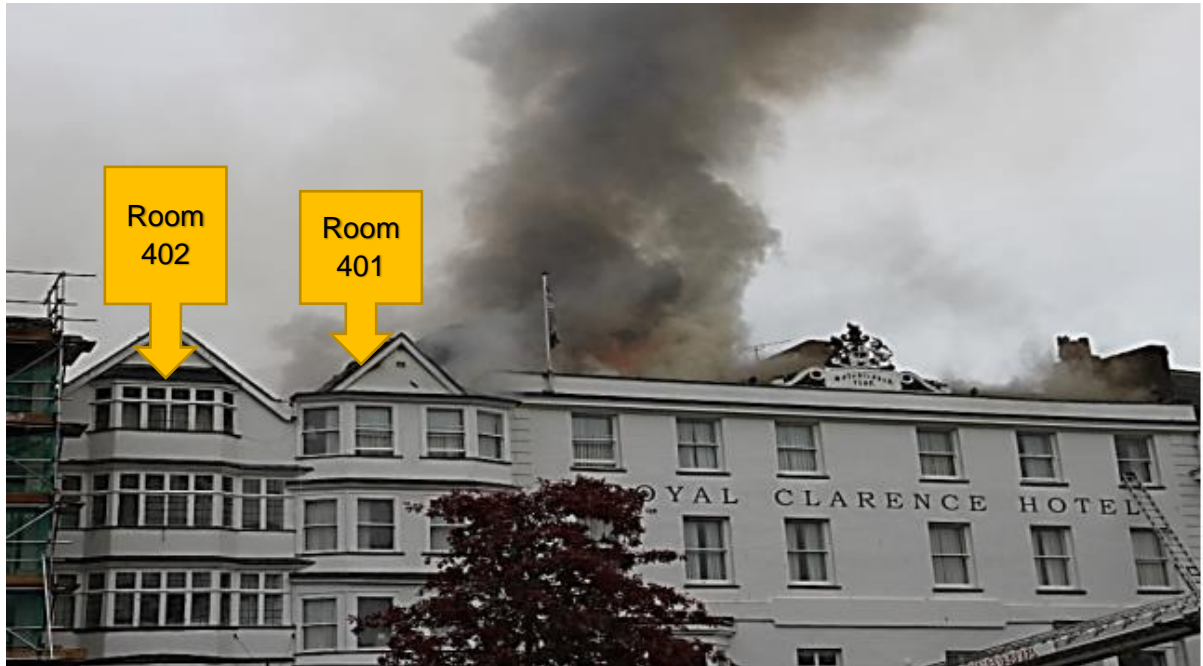
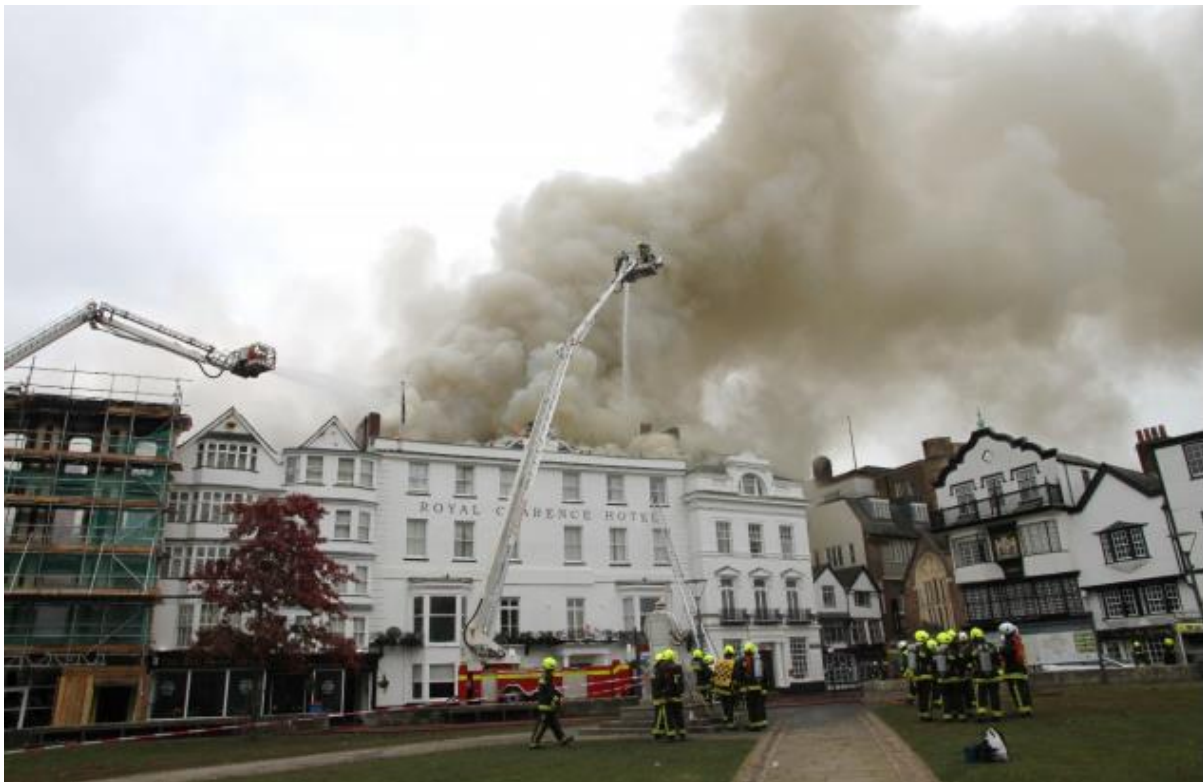
Appendix C – Pictures following escalation after 1018hrs

¹⁶ For the purpose of this review, escalation refers to the time of approximately 1018hrs where fire was observed breaking through the RCH roof.
